(NASA-TM-X-70381) EVALUATION OF GROUND
CHARACTERIZATION SAMPLES MCN-2 AND MCN-3,
SECTION 1 (NASA) 56 p HC \$6.00 CSCL 13H

SECTION I. EVALUATION OF GROUND CHARACTERIZATION
SAMPLES MCN-2 AND MCN-3

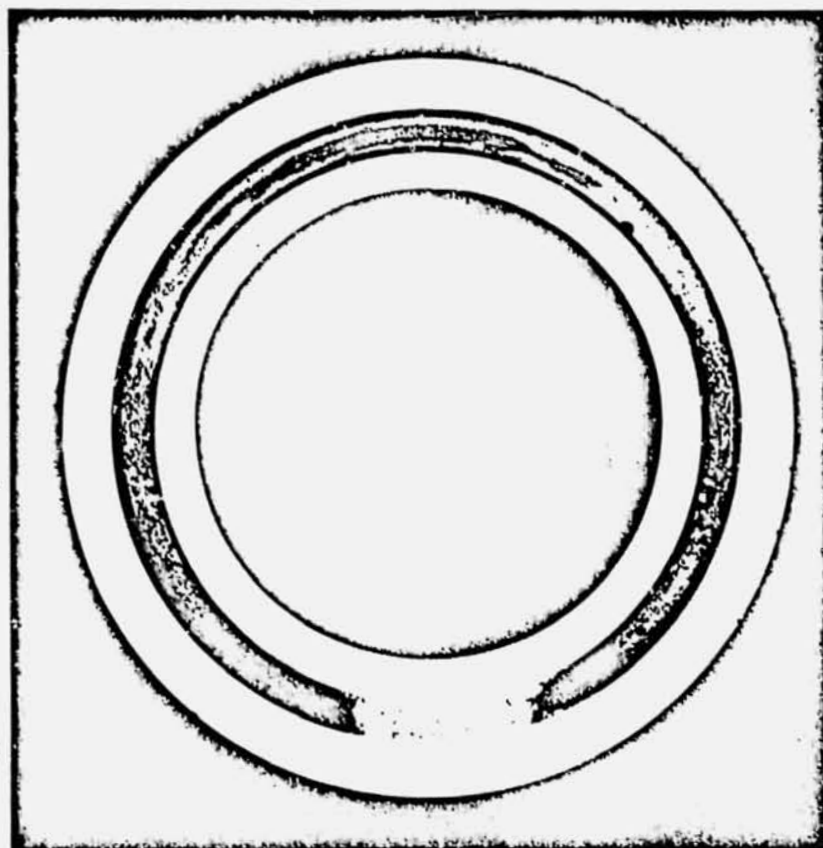
FIGURE I-9. SECTION MCN-2-3

A section of the right-hand filler metal ring groove is shown at 4X in Figure I-9. The accumulation of filler metal at the bottom of the ring groove indicates that the tube assembly was brazed in the orientation shown in this figure. Capillary forces were ineffective because the ring groove was too wide (0.055 inch). As a result, the filler metal collected in a puddle due to gravity and it did not form a smooth meniscus. Nevertheless, sufficient flow occurred to coat the entire surface of the ring groove with a thin film of filler metal.

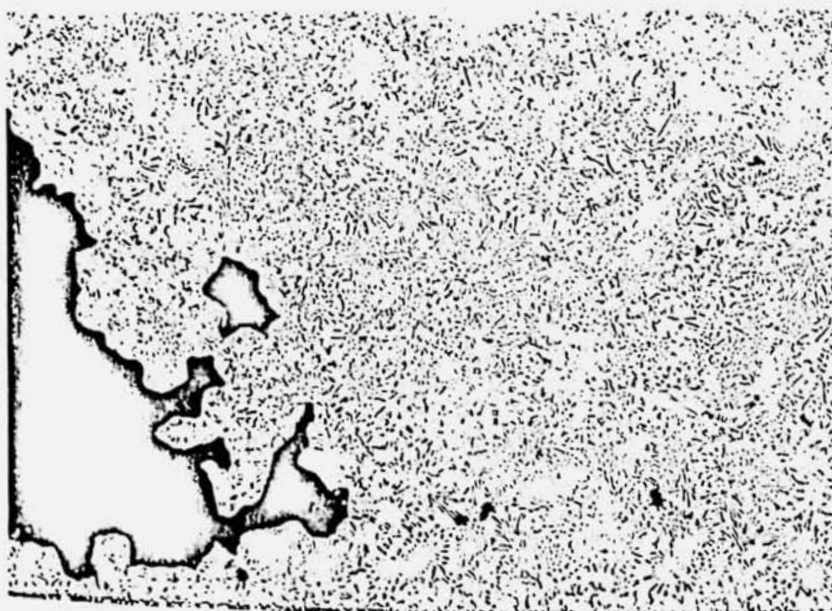
FIGURE I-10. SECTION MCN-2-3

A section near the left-hand edge of the accumulated filler metal is shown at 100X in Figure I-10. There are some isolated voids in this area. The microstructure is largely comprised of a eutectic phase and another phase resulting from the reaction of the filler metal with the base metal.

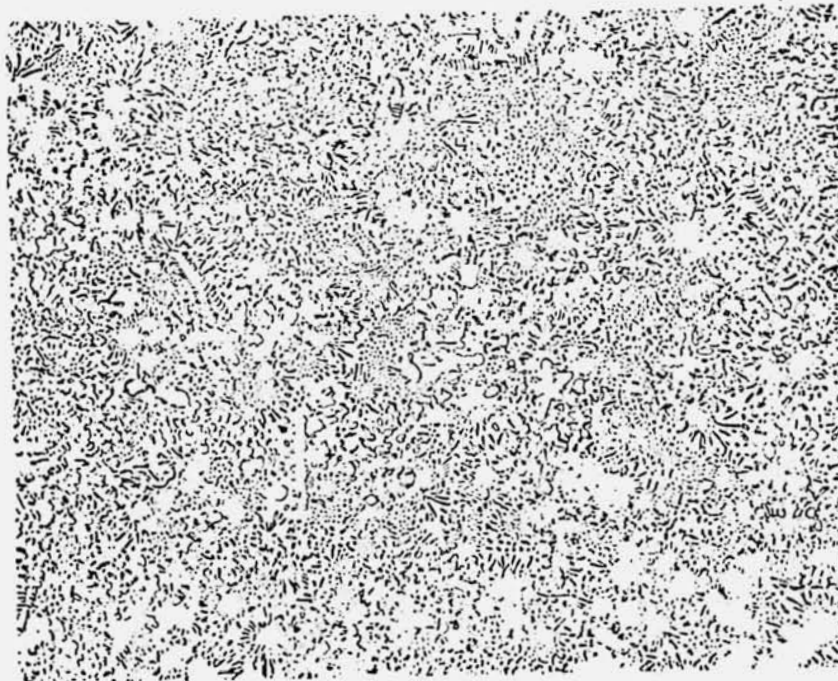
FIGURE I-14. SECTION MCN-3-2

The microstructure of the accumulated filler metal is shown at 100X in Figure I-14. It is similar in appearance to microstructures examined previously.

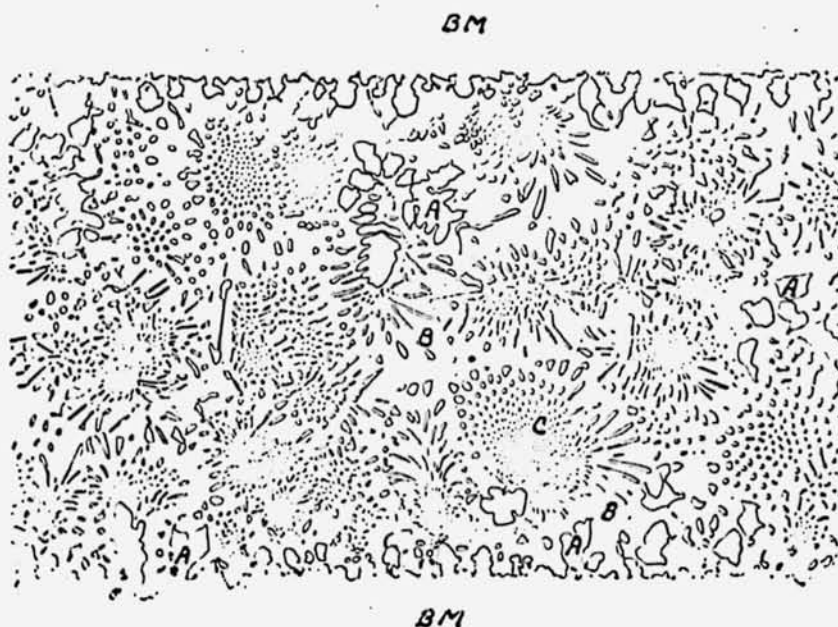
An unetched section of the nickel tee-joint is shown at 250X in Figure I-21a; for direct comparison, a section from MCN-2 is shown at the same magnification in Figure I-21b (this figure is identical to I-4). The microstructures of these joints reflect differences attributable to the brazing conditions. The amount and distribution of the copper-rich phase (A in Figure I-21a and I-21b) indicates that more reaction between the base metal and filler metal occurred in the exothermically brazed joint than in the furnace brazed joint. However, the width of the reaction zone at the interface was comparable for both joints. The microstructure of areas at some distance from the joint interface differs considerably. In the furnace-brazed joint (Figure I-21a), there is a silver-rich dendritic phase (C) dispersed in a matrix of the silver-copper eutectic (D). In the exothermic-brazed joint (Figure I-21b), the following phases are present: a copper-rich phase (A), a phase that is essentially pure silver (B), and a phase that was not identified (C).

The differences in the microstructures of exothermically-brazed and furnace-brazed joints appear to be primarily attributable to the difference in the brazing thermal cycle.

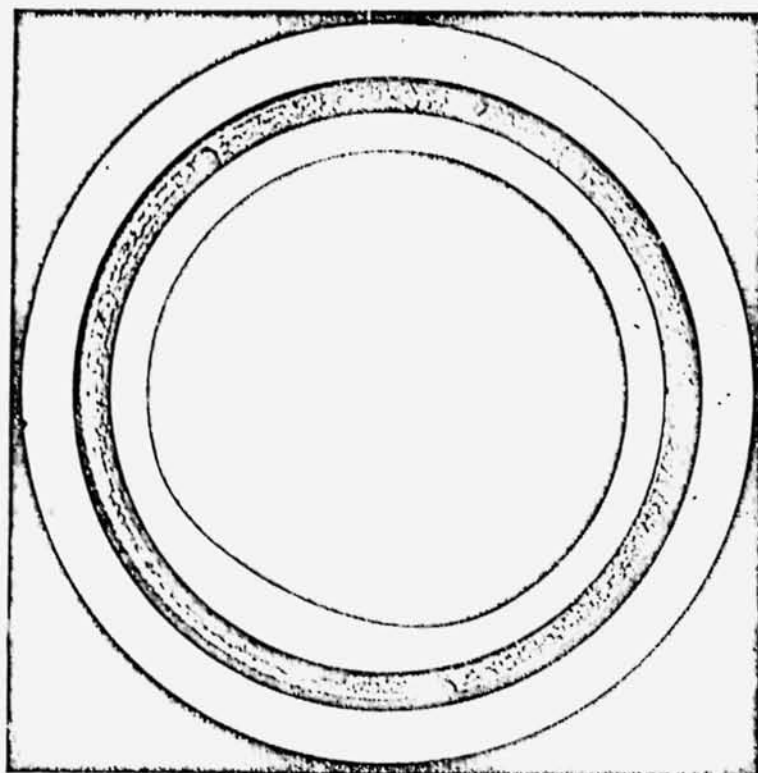
FIGURE II-11. SECTION MCS-1-9

A section through the left-hand filler metal ring groove is shown at 4X in Figure II-11. The ring groove is empty; however, its surfaces are covered with a very thin film of filler metal. Filler metal has accumulated at the bottom inside of the tube. The microstructure of the accumulated filler metal is similar to that observed in other sections of this joint.

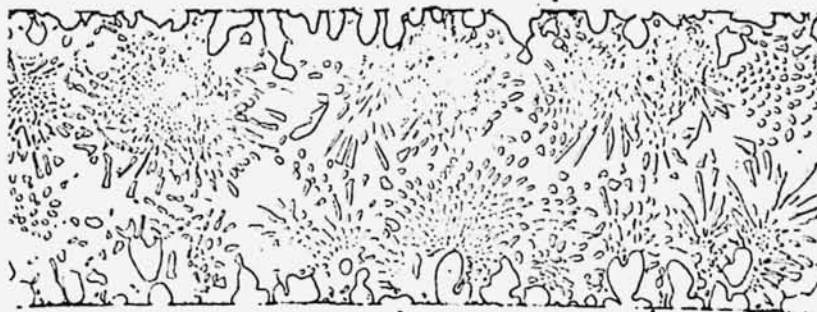
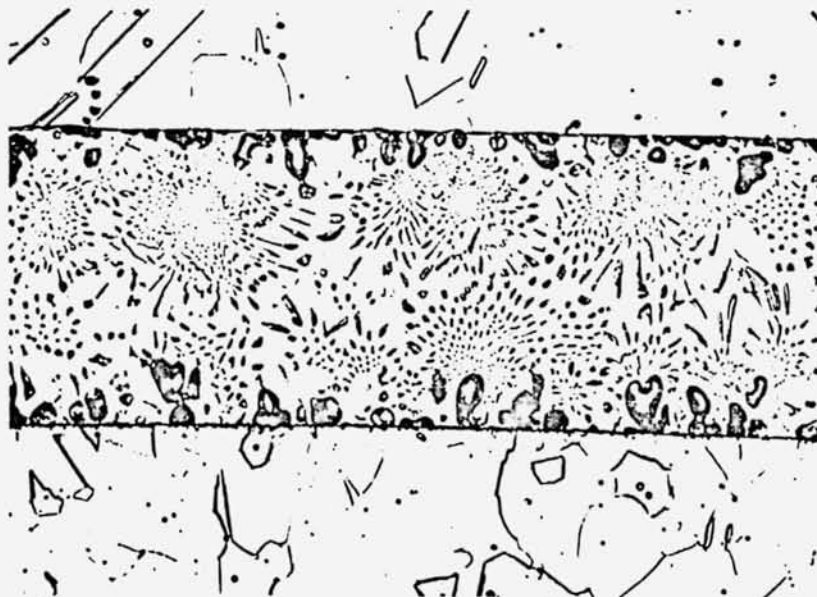
The full circumferential joint between the tube and sleeve is shown at 4X in Figure II-13. The joint quality was excellent and there were no void areas of significance. A section of this joint is shown in the unetched condition at 250X in Figure II-14a; the same section is shown etched in Figure II-14b. The joint microstructure appears similar to those observed in sections from Sample MCS-1.

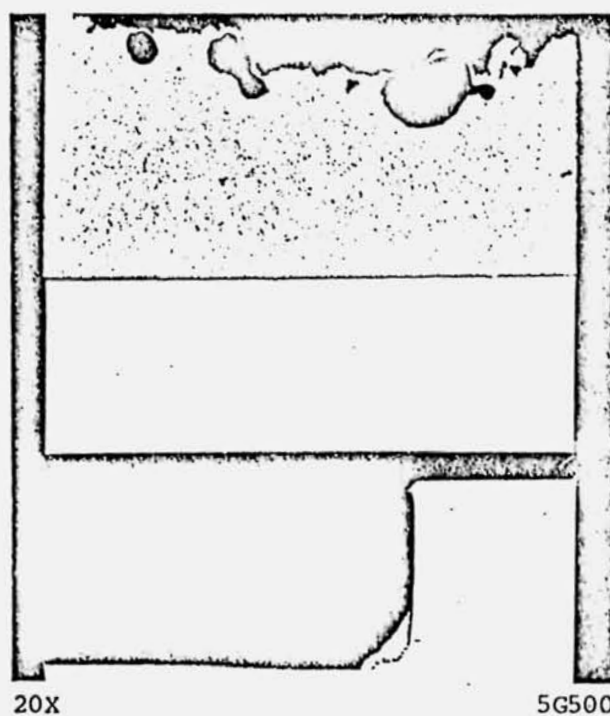
FIGURE II-18b. SECTION MCS-3-2

The lower half of this section is shown at 20X in Figure II-18b. The ring groove is essentially void except for some filler metal remaining in one corner. This section of joint between the tube and sleeve is completely void; however, the joint in the upper half of this section was well filled with filler metal. The presence of voids in this area was indicated by radiography. As observed previously with Samples MCS-1 and MCS-2, filler metal accumulated on the bottom inside of the tube during brazing. However, the surface of the accumulated filler metal was extremely rough and there were numerous indications of voids or porosity. In contrast, the surface of the accumulated filler metal in the other two samples (MCS-1 and MCS-2) was very smooth. Due to an equipment malfunction, the maximum temperature to which Sample MCS-3 was heated during brazing was about 100 F (37.8 C) lower than the temperature to which the other samples were heated. Apparently, the surface roughness is associated with the manner in which the filler metal flowed and solidified.
